**0.0 LATE ITEM: FLOOD EVENTS 15 & 24 JULY 2026****File Number:****Report Author:** Water Services Manager**Report Authoriser:** Group Manager Operations**Appendices:** Nil**1. REPORT PURPOSE**

**3. SUMMARY OF EVENTS****3.1. 15 July 2026 – Flood Event**

### 3.2. 24 July 2026 - Flood Event

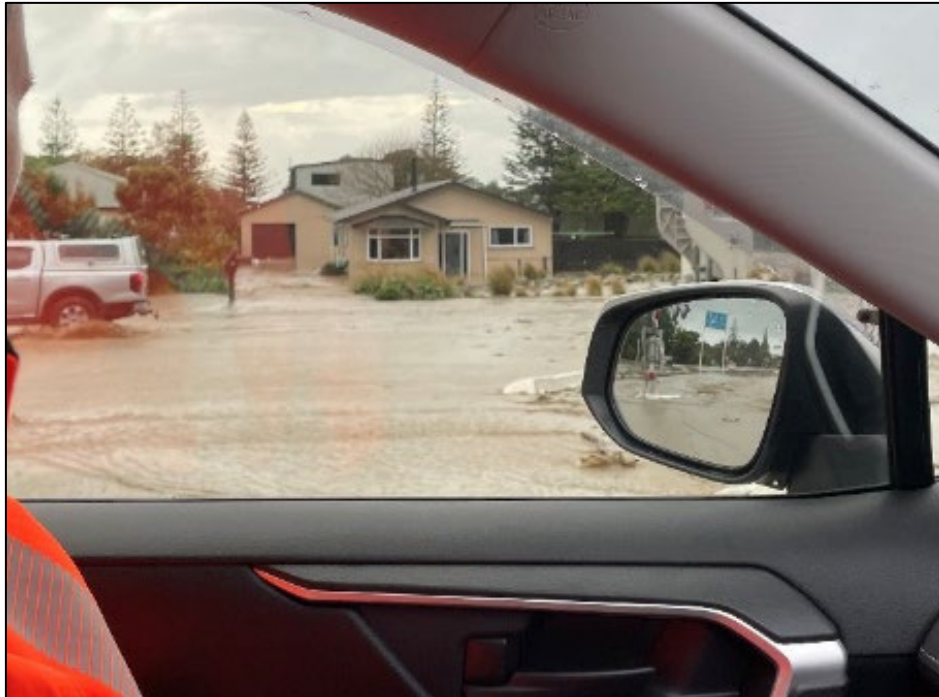
Fig 4: 80 Tasman Street, Karoro

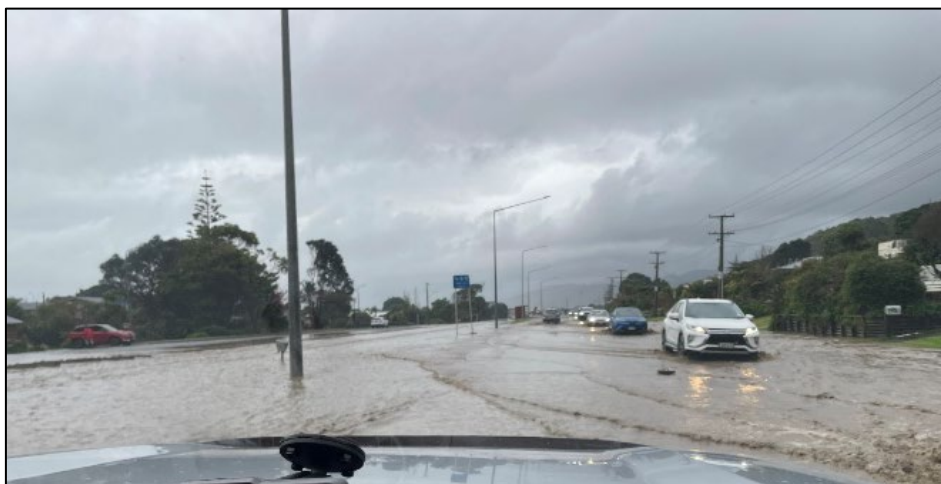
Fig 5: State Highway 6 - Rail line adjacent to Rata Street, Karoro

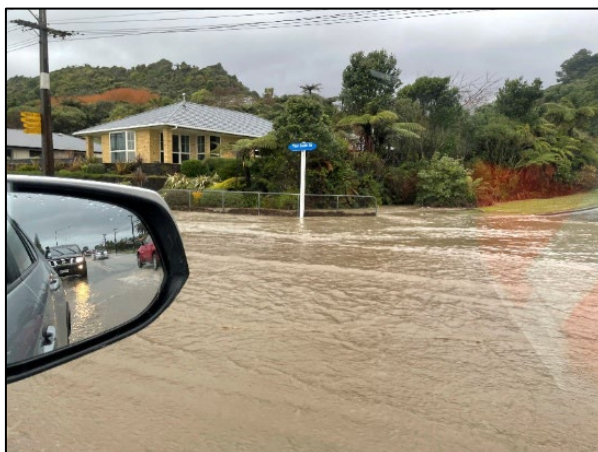
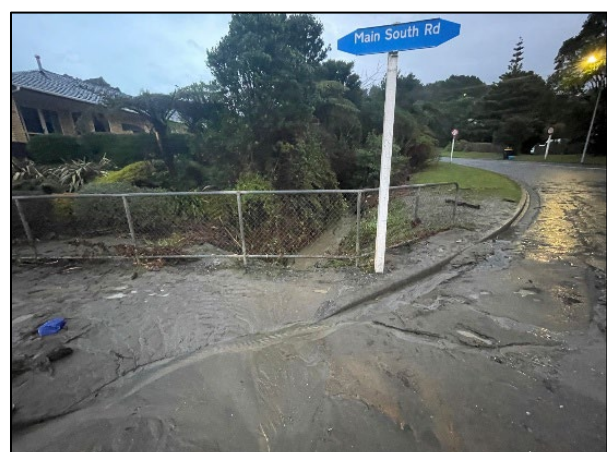
Fig 6: Culvert intake at Weenink Road, Karoro

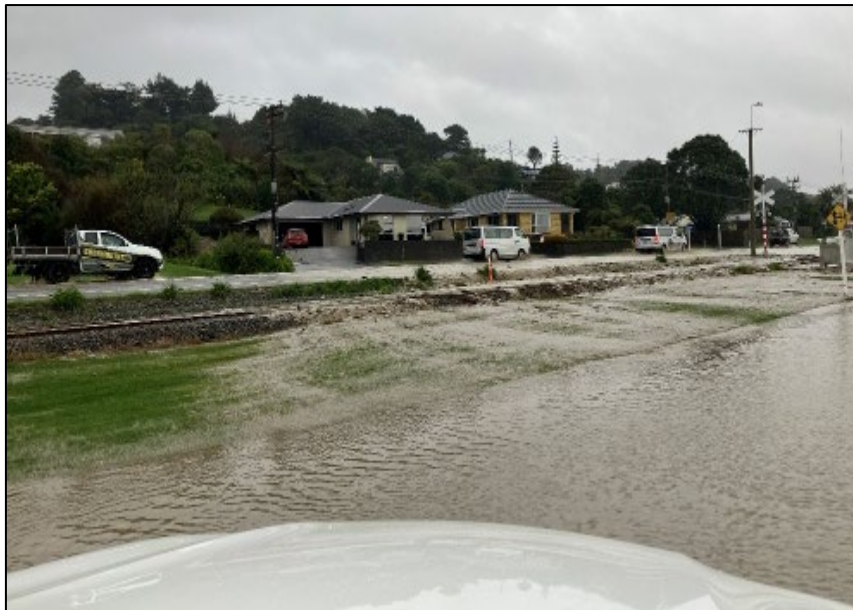
Fig 7a: Flooding at its peak, Tasman Street, Karoro

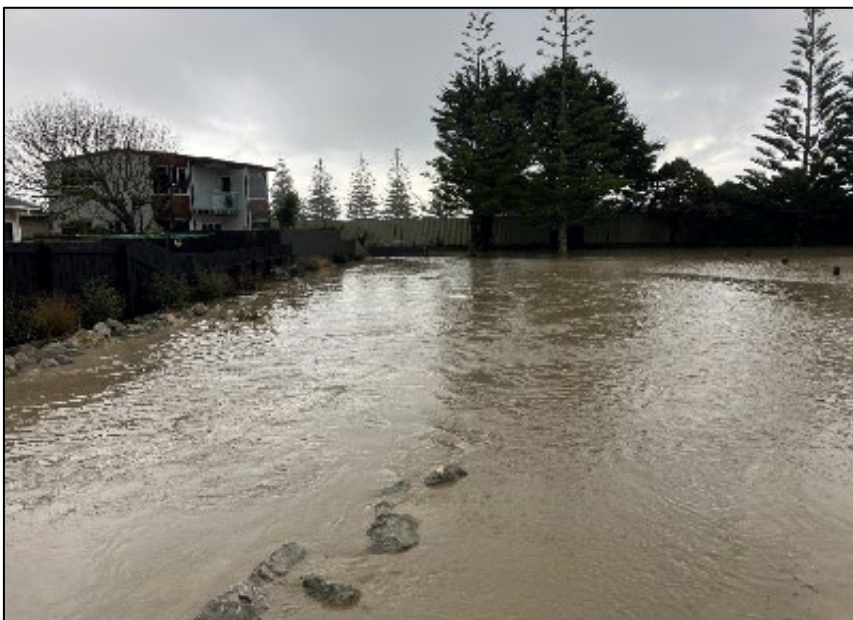
Fig 7b: Flooding at its peak, Tasman Street, Karoro

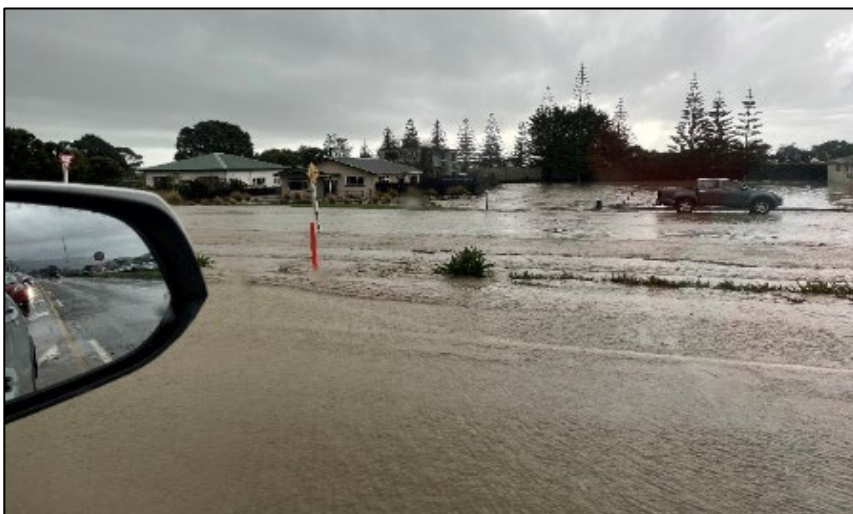
Fig 7c: Flooding at its peak, Main South Road, Karoro

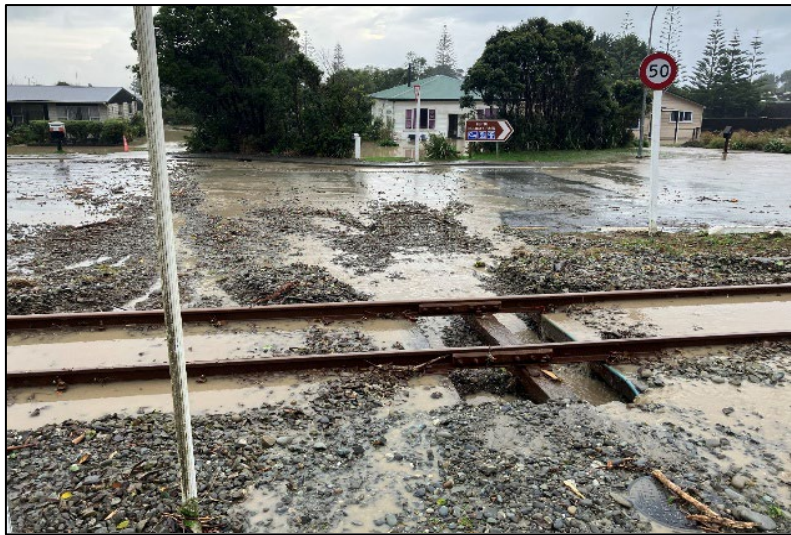
Fig 8a: Rail damage adjacent to the Tasman street/SH6 intersection, Karoro

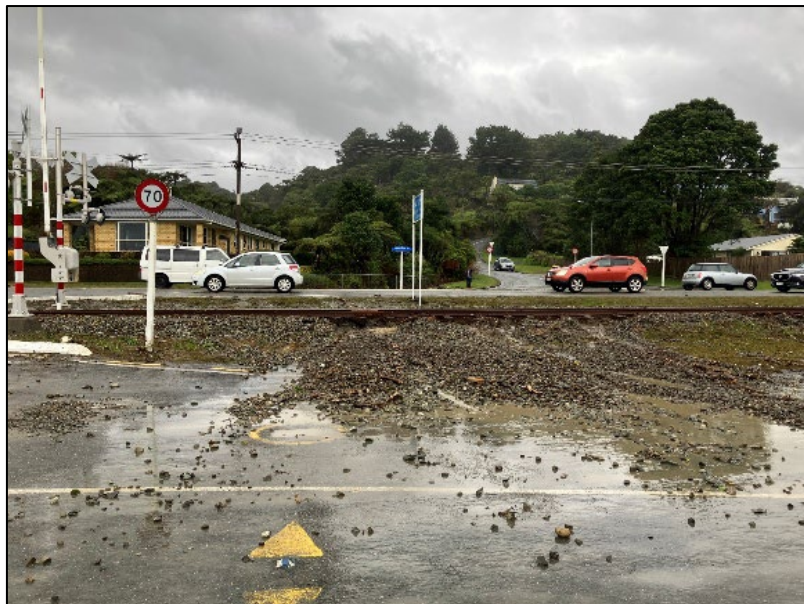
Fig 8b: Rail damage adjacent to the Tasman street/SH6 intersection

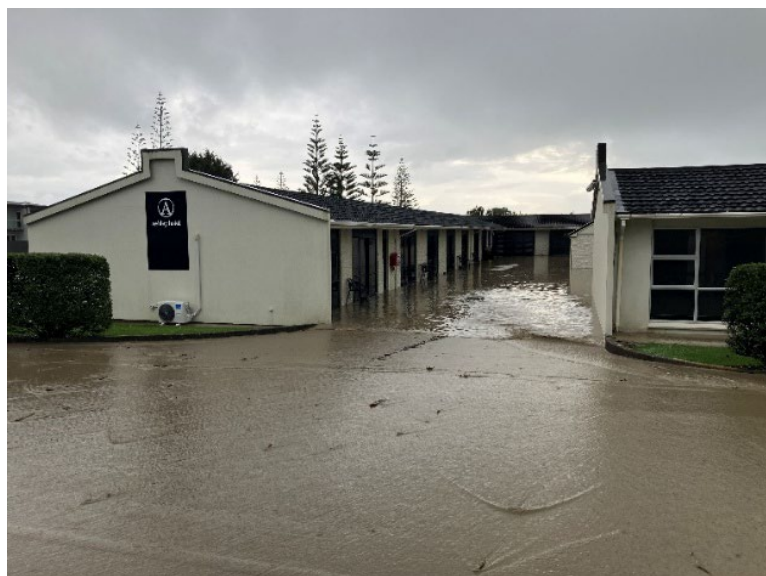
Fig 9: Motel inundation, Tasman Street, Karoro

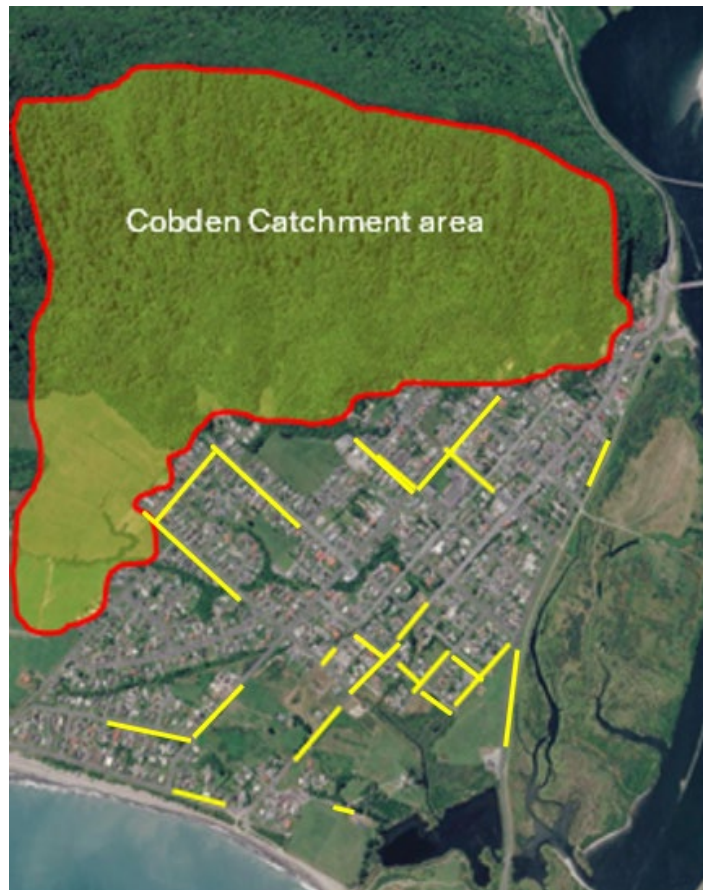
Fig 11. Cobden estimated catchment area and the worst flooded streets.

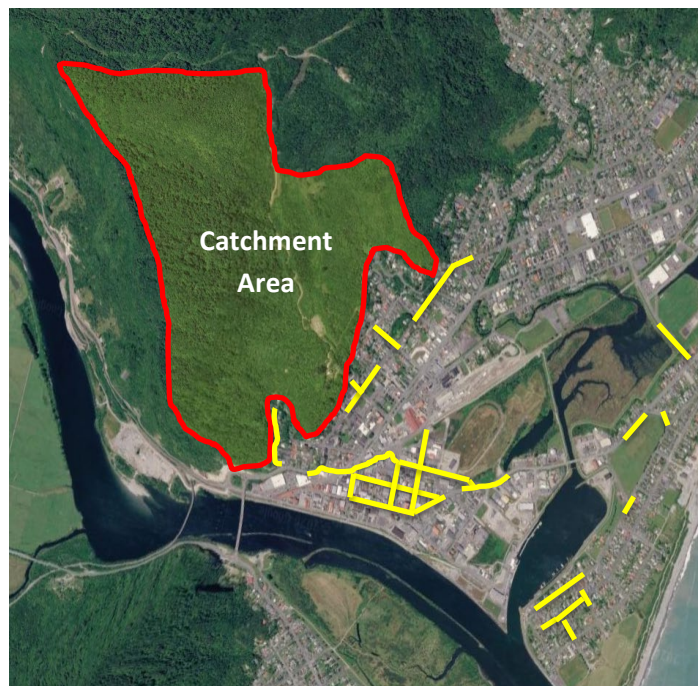
Fig 12. CBD estimated catchment area and the worst flooded streets.

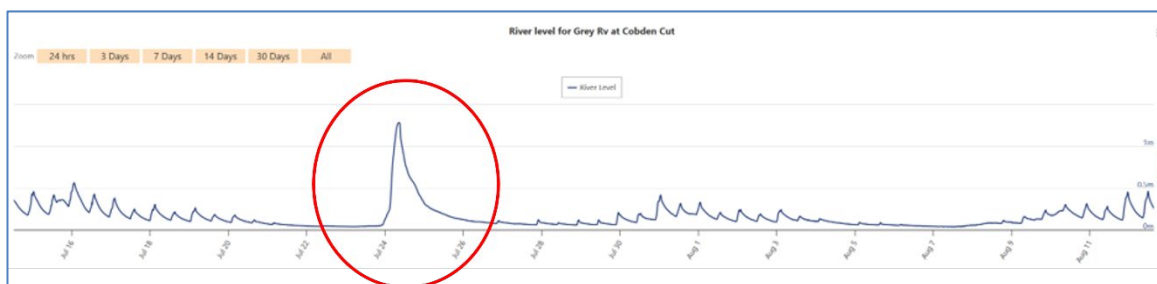
Fig.13 Cobden Lagoon WCRC Water Levels Data

- (iv) The Range Creek floodgate was identified as being shut, at 7:30 am on the morning of the event. This was immediately opened by our contractor.

- a. An extensive investigation has been undertaken following this event. The last time the flood gate was recorded being operated/closed, was on the 5 of May (during a high Grey River event). It was opened following this event.

- b. WCRC Cobden lagoon monitoring information confirms the gate was open following the event, as can be seen by the cyclic tidal effect on the below graph. The WCRC data does show however that the tidal effect on the lagoon ceased on 21 July 2026, indicating this is the date the floodgate was closed. How the gate was closed is still a matter of investigation, but investigation to date, confirm this was not actioned by Council or its contractors.
