# Demolition of the Heritage listed Old Greymouth Courthouse (HH68)

Ministry of Justice

8 Guinness Street, Greymouth

Resource Consent Application to Grey District Council

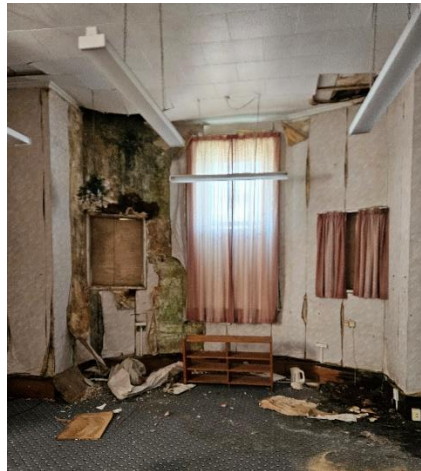
In the intervening years the building has substantially deteriorated to its current condition. The interior has suffered damage from intruders and the ingress of moisture. There are signs of mould and vandalism.

Signs of mould and water ingress

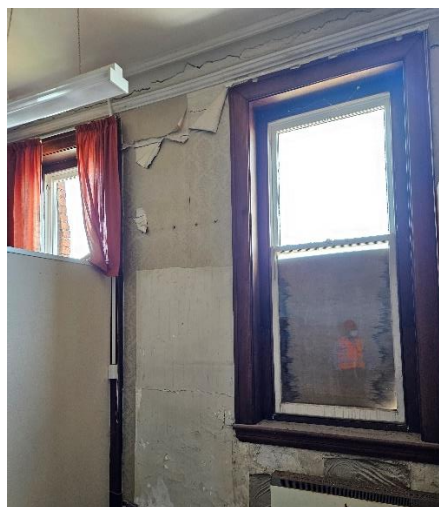
Structurally there are areas of external brickwork on the west elevation that are bulging to the point of likely collapse. There are related horizontal cracks at the ceiling level on this elevation that are symptoms of seismic damage. It is understood that when the MoJ became aware of these structural issues they undertook preventive measures to restrict access within the building and any adjacent fall zone.

Horizontal crack above window head

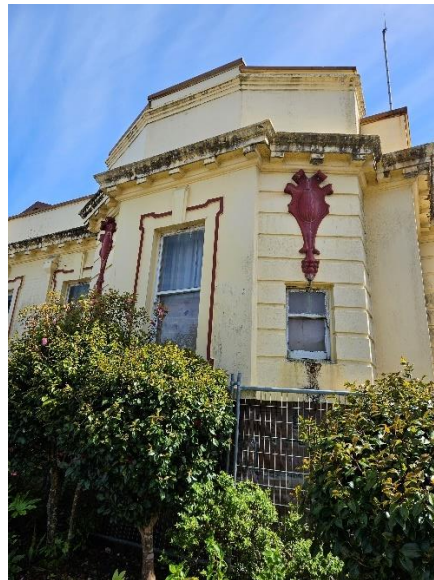
The main Guinness Street facade is fenced off with resultant vegetation growth and degradation of the painted plaster surface. It is understood that that the painted stone base, which is original stone from a nearby Dobson quarry, has been tested to contain Asbestos. The impervious painted surface has caused degradation to the underlying stone.

Vegetation growth to street elevation

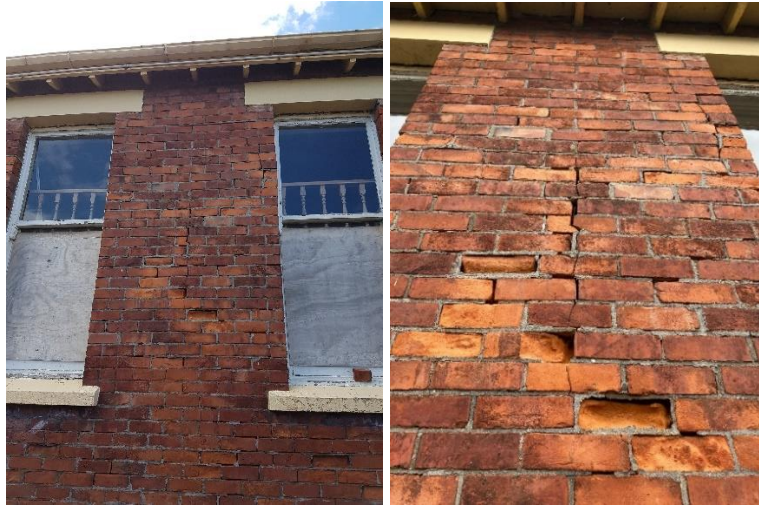
The façade veneer bricks and mortar are in very poor condition. There are extensive cracks in the veneer in some areas, and the brick ties have corroded, as shown in Figure 1. Some bricks are in poor condition, and mortar is also in poor condition. Visible bowing of the veneer walls on the western side of the building has increased by approximately 50 mm since the last visit, as shown in Figure 2. The western wall external veneer is nearing the point of out-of-plane failure due to its deteriorated state. The front wall facing the street is plastered and appears to be in better condition than the exposed brick walls.

Figure 1. Significant cracks in western external façade. The 2019 photo is shown on the left for comparison

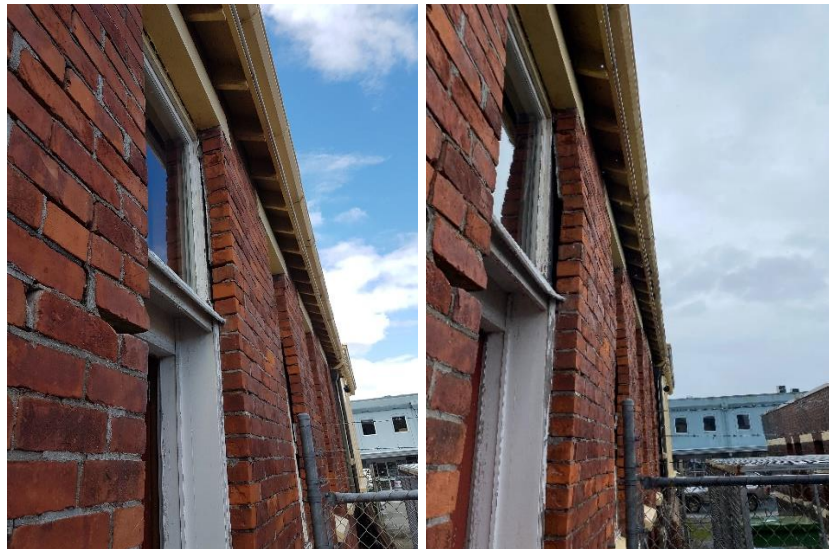
Figure 2. Visible bowing in western external façade. The 2019 photo is shown on the left for comparison

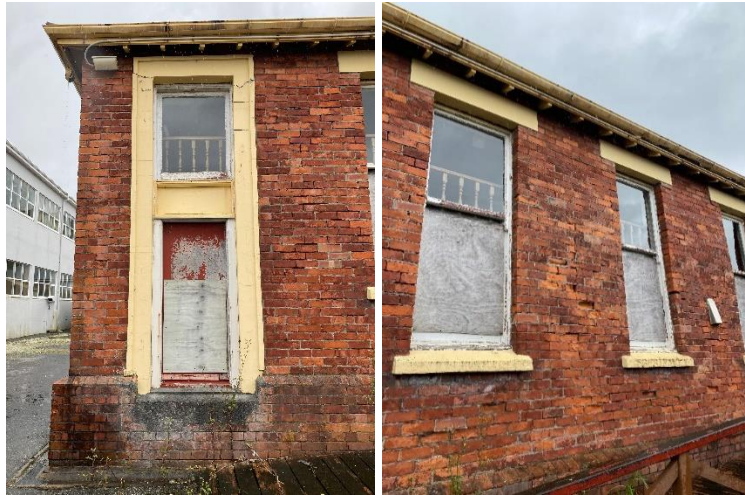
The lintel beams in the external brick veneer have rotated outwards and cracked around the edges of the beam. This is shown in Figure 3. The visible rotation is most likely caused by the brick veneer bowing outwards under pressure from corrosive scaling of ties. No cracks are visible on the lintel face.

*Figure 3. Cracks to external concrete lintels*

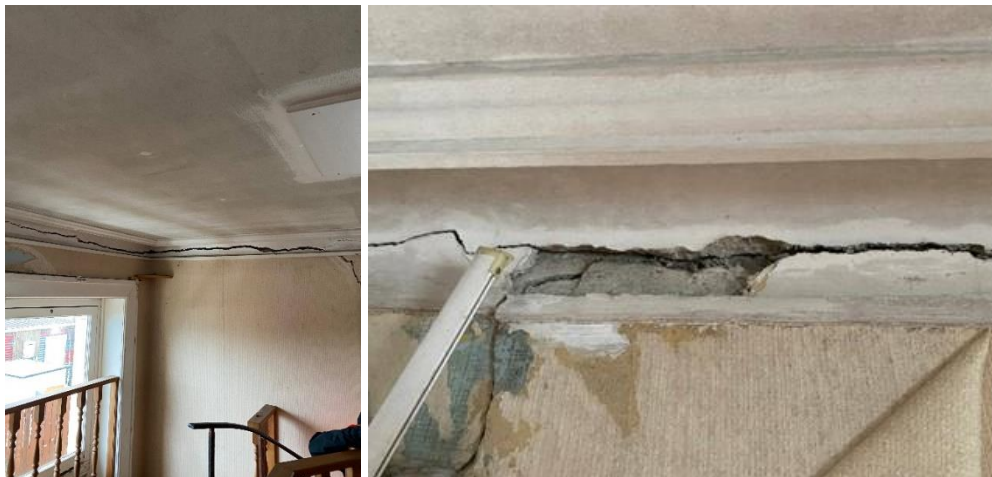
Significant cracking is present along the top edge of the internal north and west perimeter walls, as shown in Figure 4. Cracks are also present along the top edge of the partition walls perpendicular to the western wall.

*Figure 4. Cracking along top interior edge of perimeter walls*

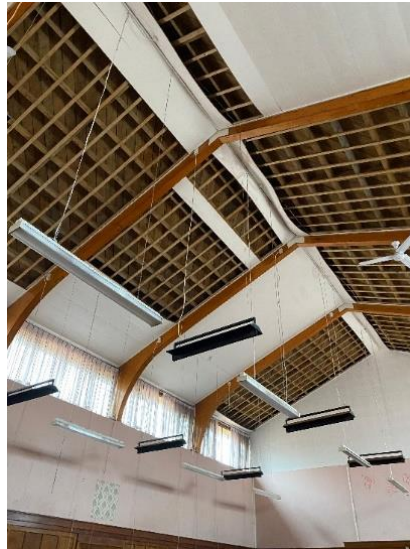
It was observed that the condition of the Courtroom Area roof structure remains satisfactory, with no obvious structural deterioration since the previous inspection. Ceiling tiles have fallen down, exposing the structure over much of the ceiling, as shown in Figure 5. The glulam rafters appear to be in reasonable condition. No delamination was observed.

Figure 5. Roof structure over courtroom area

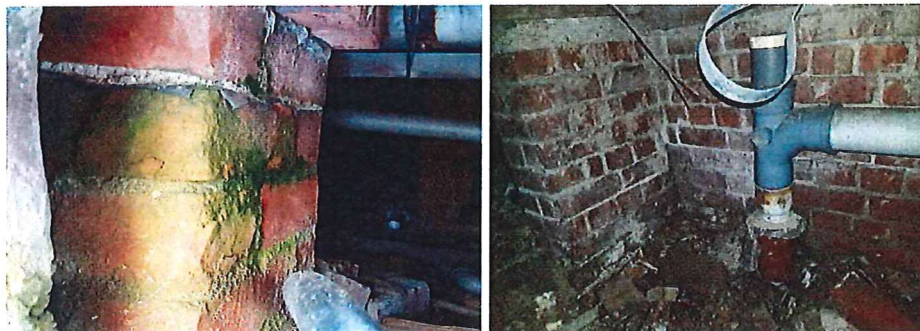
Large areas of the building were found to be damp or wet. The foundations were waterlogged likely due to ineffective drainage from down-pipes. The DPC layer on the foundations was intact, however, above the layer the URM walls were still damp.

Figure 7. Damp Foundations with DPC Layer

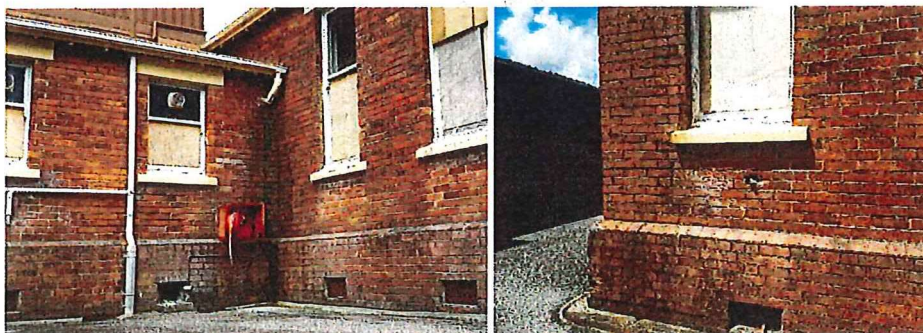
Broken or missing drain pipes around the perimeter of the building has led to water travelling from the guttering and down the façade. This has accelerated the deterioration in these localised areas and caused dampness of the walls.

Figure 8. Dampness of Foundations and Walls

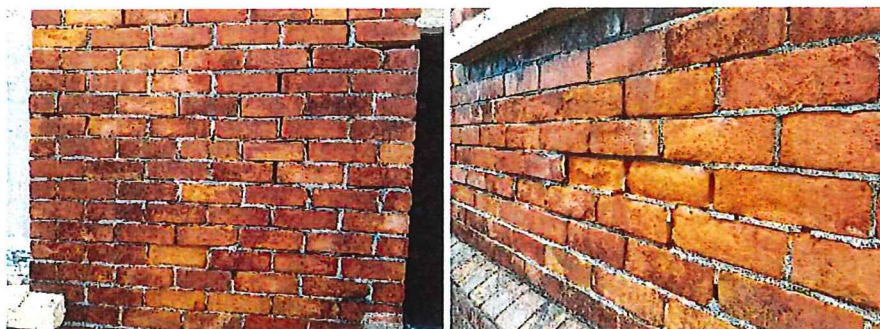
The condition of the façade veneer bricks and mortar is very poor. The mortar comprises of beach sand and is able to be raked out with finger pressure. The veneer is extensively cracked, brick ties have corroded and are no longer effective. Bowing of the veneer walls is visible by eye.

Figure 9. Poor Condition of Façade Veneer

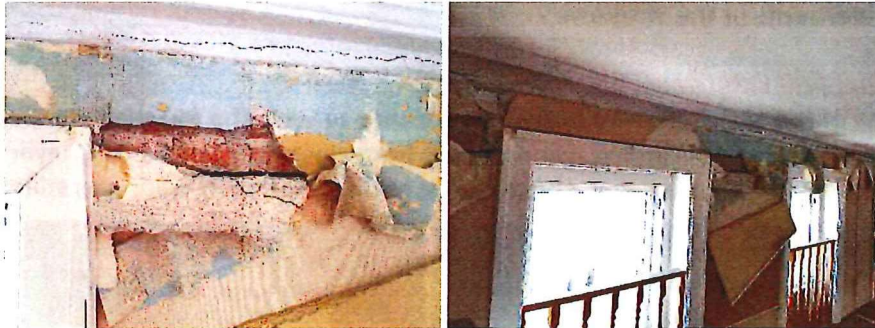
Cracking is present along the top edge of the internal north and west perimeter walls. Cracks are also present along the top edge of the partition walls perpendicular to the western wall.

Figure 10. Cracking of the Internal Perimeter Walls

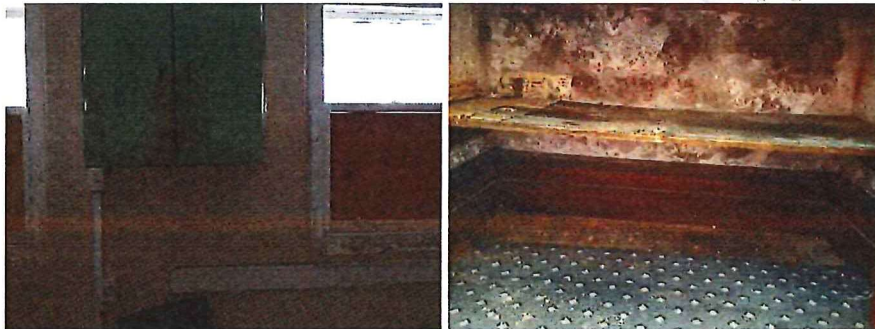
The internal walls contain a large amount of mould, indicating dampness of the interior walls to the full height of the wall. The mould was most prominent along the north wall.

Figure 11. Dampness of Internal Walls

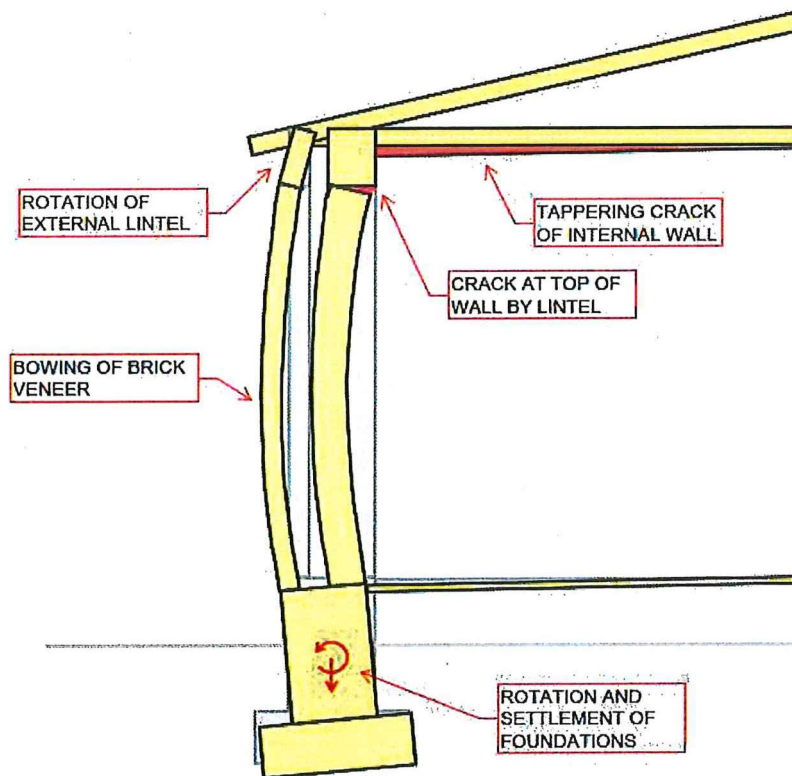
Damage is mostly observed along the full length of the building's western wall and sections of the northern wall. Subjecting the foundation strip footing to a rotation and settlement results in a tapering gap along the top of the partition. Bowing of the external veneer would result from the rotation of the support and resulting extra total height would be taken up by the expansion of the steel ties. Due to the structure containing a separate lintel for each wall, the veneer lintel would be free to rotate with the façade due to not taking load from the roof truss. The internal lintel would remain in position due to support from the roof and larger size. Bowing of the internal wall would, therefore, create a gap along the top each of the wall underneath the concrete lintel. Figure 12 illustrates how this damage could form from the rotation and settlement of the foundations.

Figure 12. Diagram of Probable Cause of Damage

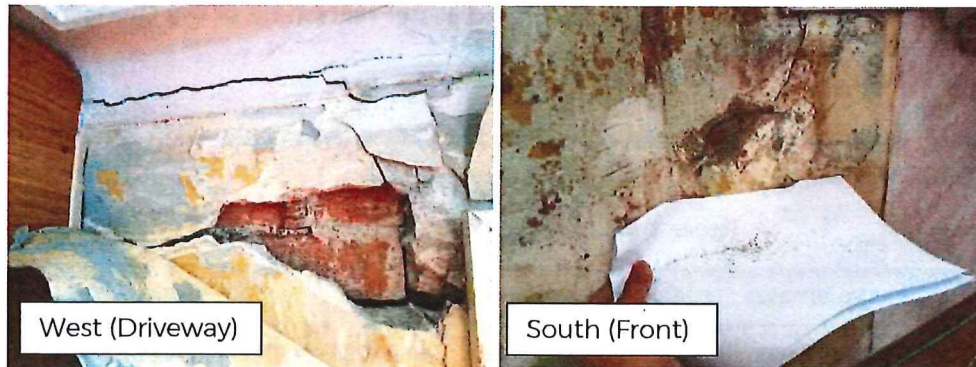
As per the methodology set out in Section C8 of the Guidelines, on-site scratch tests were performed on the bricks and mortar around different areas of the building. There was limited access to the brickwork of the perimeter cavity walls. Figure 19 shows areas that were exposed. The bricks were able to be scratched with finger pressure and determined to be classified as soft. The brickwork is covered in render with similar properties to the mortar and is very moist, crumbling under finger pressure and removable using a copper coin.

Figure 19. Condition of Bricks and Mortar on perimeter walls

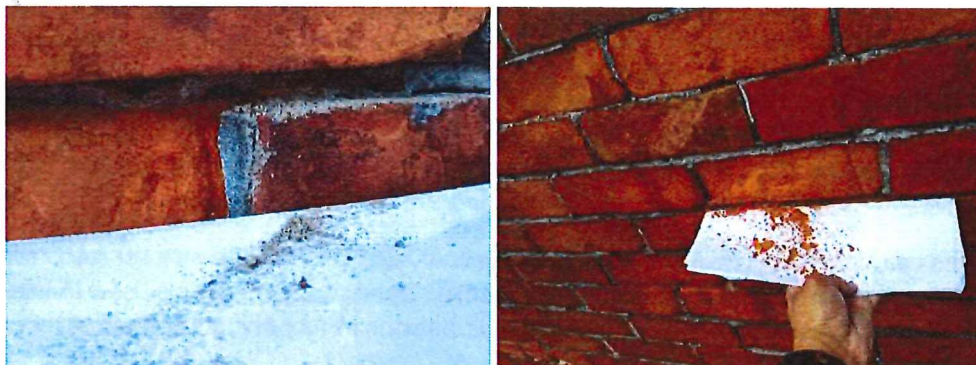
We suggest that excessive exposure to sea-spray, particularly in West and North, is the cause of this damage. The corrosion of brick ties has further contributed to this damage. Therefore, it was deemed that the veneer bricks and mortar have no reliable strength and are at the point of collapse given the visible outward bowing.

Figure 20. Condition of Bricks and Mortar on Exterior Veneer

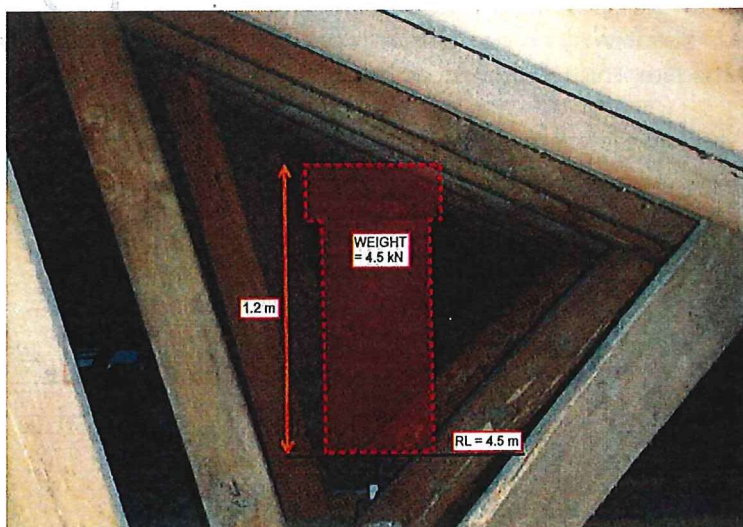
Figure 25. Remaining Chimney in Ceiling Cavity

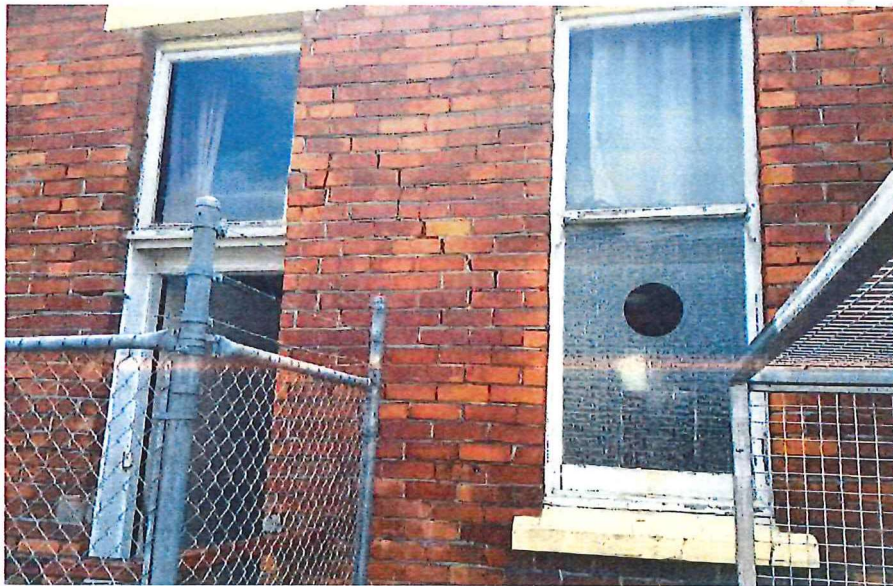
Figure 26. Cracking in Brick Veneer
