# Demolition of the Heritage listed Old Greymouth Courthouse (HH68)

Ministry of Justice

8 Guinness Street, Greymouth

Resource Consent Application to Grey District Council

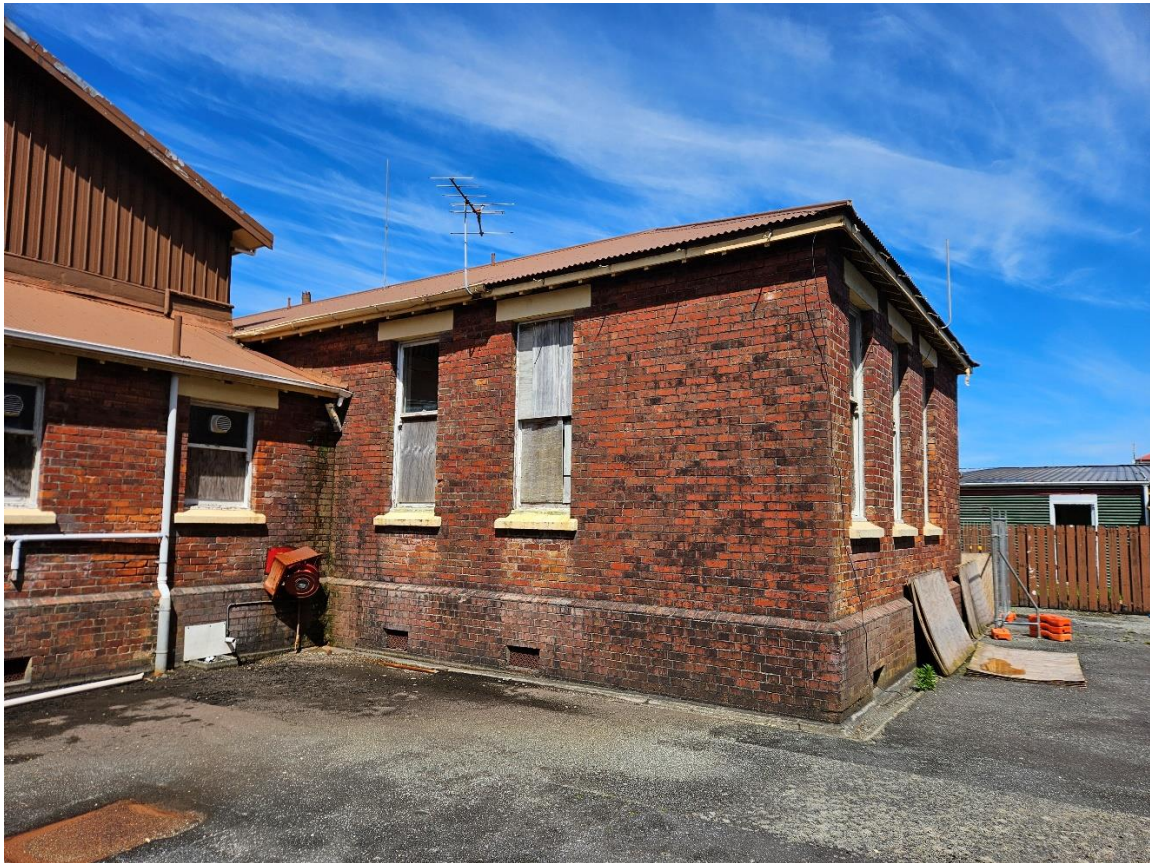
Rear brick construction

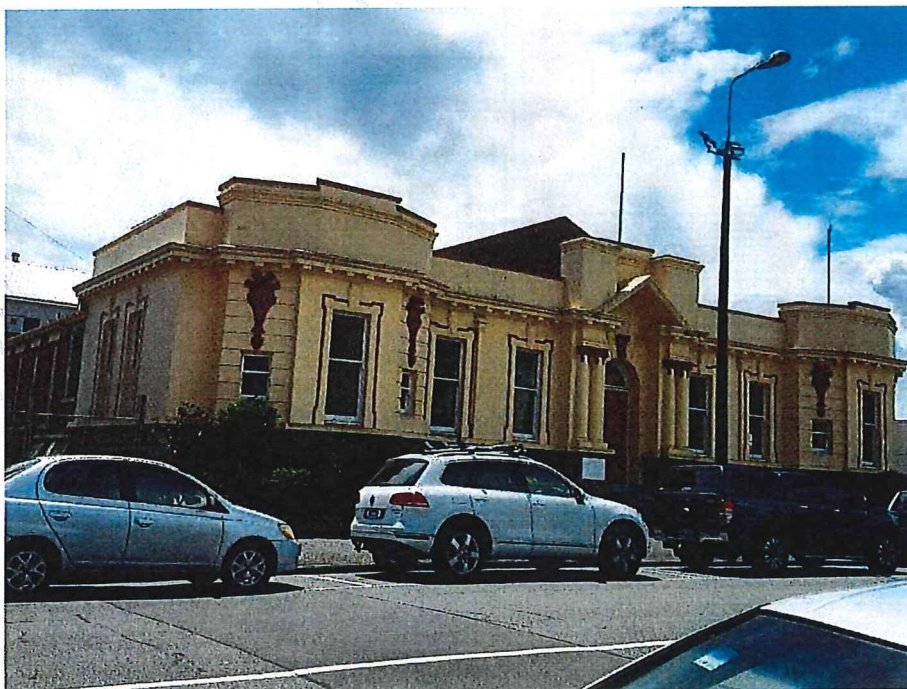
Figure 2. Photo of Building in Current State

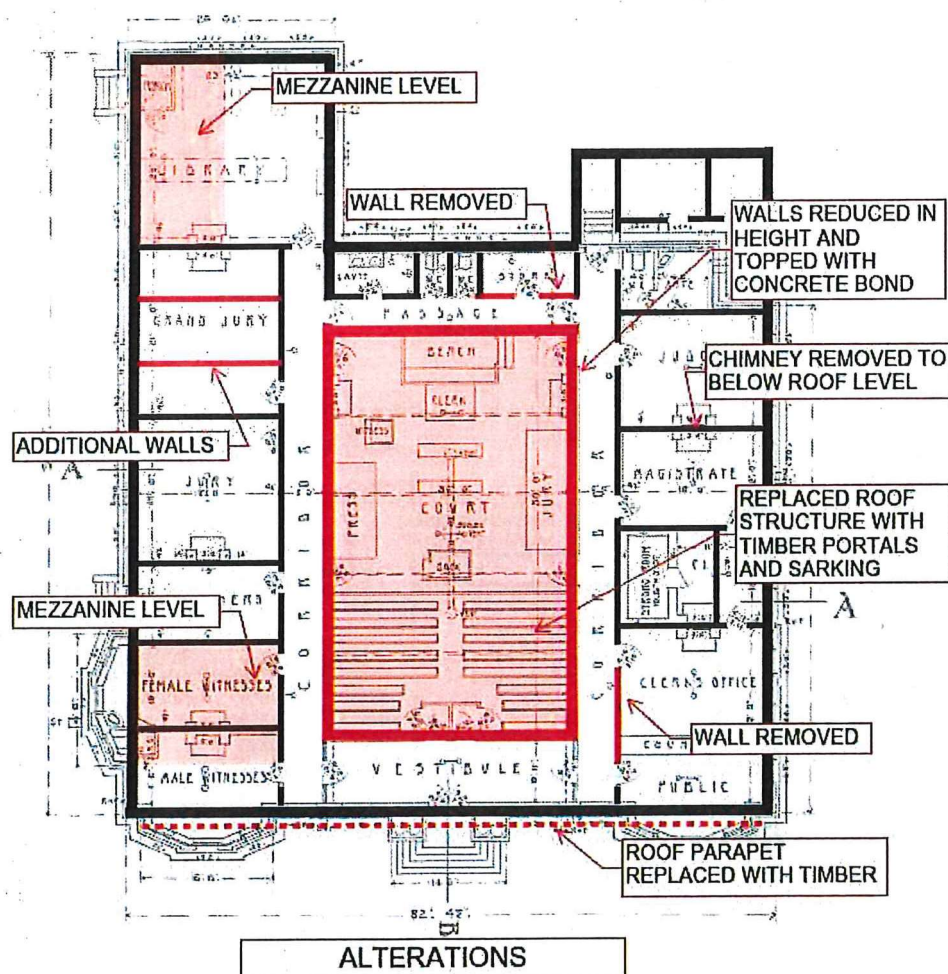
Following the 1968 Inangahua earthquake, which forced the evacuation of the Courthouse, a series of alterations were carried out. The main courtroom walls were reduced in height to 3.8 m, the same level as the other walls. The roof diaphragm over this section was also replaced with timber glulam portals, which were topped with diagonal timber sarking and roofing iron. Due to lessons learned from the earthquakes in the early 1900s, the heavy ornaments were removed from the building. This included removing the URM parapet and replacing it with a timber replica and removing brick chimneys from above the roof. Alterations of the building are summarised in Figure 5.

Figure 5. Alterations to the Original Structure

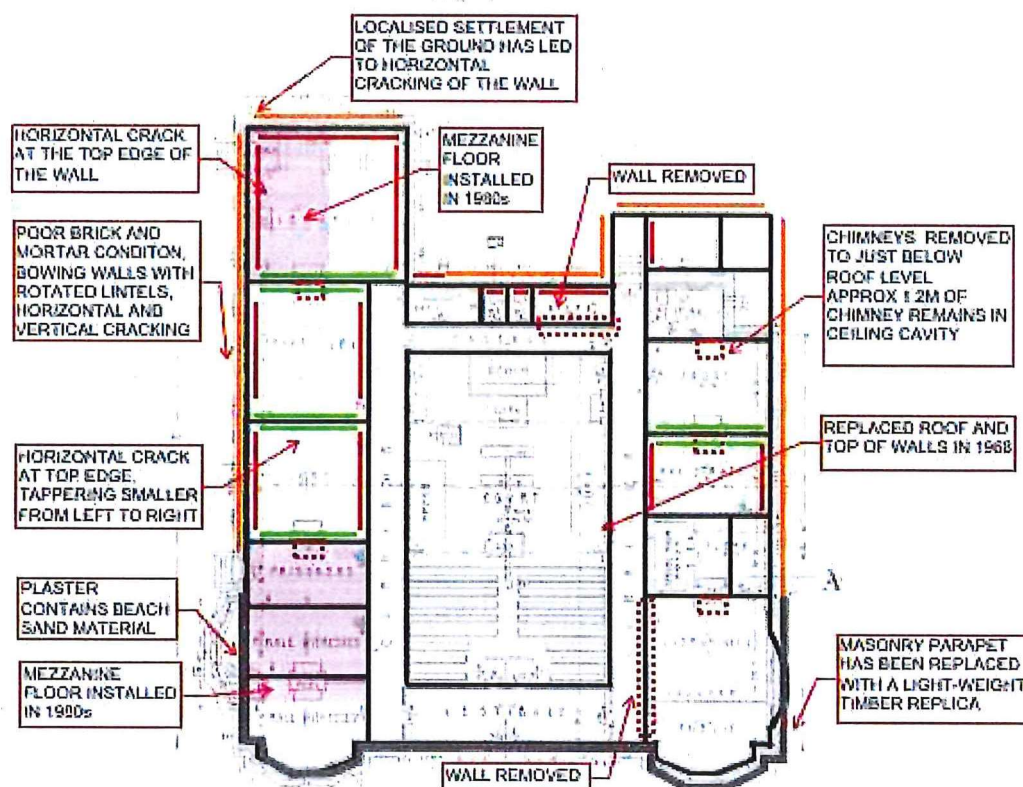
The first site inspection was undertaken in 1974, where there was minor cracking reported in the URM walls and the lime mortar was described as deteriorating but fair. The building was concluded to be in fairly good condition but recommended to be replaced by 1980. A review of the condition in 1999 found cracks that had formed along the top edge of the walls after the flooding were growing in length and size. These cracks were located on the western side of the building. The building was inspected in 2000 to report on cracking. It found the external brick veneer to be in very poor condition with a number of bricks eroding, many mortar joints cracked, and significant areas of the soft lime mortar missing. The veneer was deemed no longer water resistant. The building was again inspected in 2001, which found the cracks at the top of the walls had increased in size since the assessment the year prior. It was also suggested that the roof was bearing directly on the exterior veneer. In 2011, an in-depth condition assessment was completed, which found the condition to be generally poor, particularly the exterior brickwork and corresponding lining of the western and northern walls. A visual inspection of the exterior veneer on the western walls was done in 2014, which summarised that the condition had continued to deteriorate further with visible cracking and bowing of the piers. Figure 6 summarises the information gathered from the previous assessments.

Figure 6. Summary of Knowledge from Previous Site Inspections

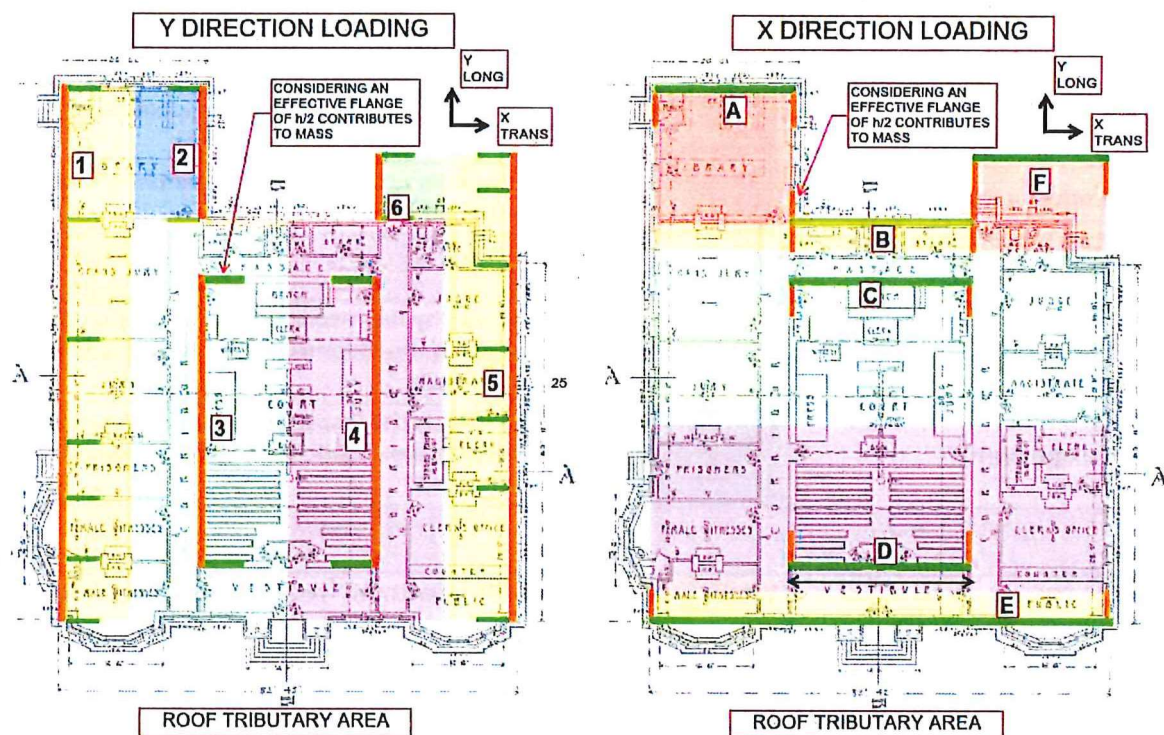
The layout of the walls for the longitudinal and transverse directions is shown in Figure 21. The perimeter cavity walls have been assessed considering only the internal wythe due to the poor condition of the external wythe. The demands were calculated using the tributary roof area along with the self-weight of the wall itself. A ductility of 1 was adopted for the assessment due to the brittle behaviour of the unreinforced masonry walls.

Figure 21. In-Plane Wall Loading

Sliding shear and diagonal tensile shear resistance are considered fundamental to the capacity of the walls. The critical case was the perimeter wall 'Wall 5', which was assessed to be 25% capacity over demand ratio (IL2) limited by its in-plane capacity. This is due to it being required to resist a large portion of the earthquake demands. The courtroom walls were rated at 35% capacity/demand ratio (IL2) under x-direction in-plane loading.

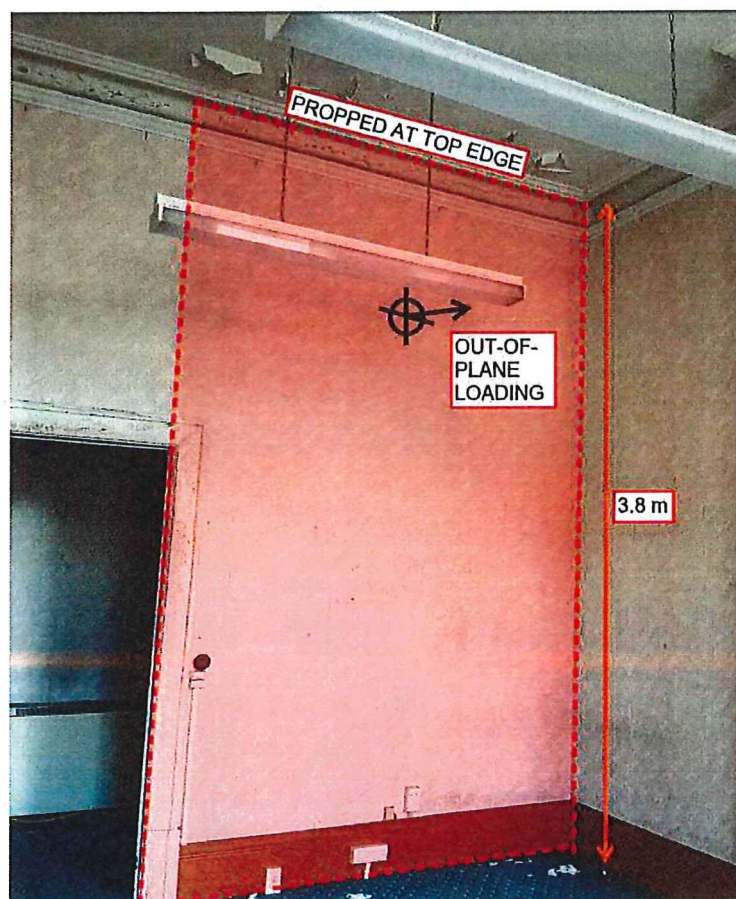
Figure 22. Out-of-Plane Loading on Internal URM Walls

The courtroom walls, due to their relatively large thickness in comparison to their height, were assessed to be 45% NBS (IL2). The contribution of the concrete bond beam was ignored due to the age and condition. The bond beam was considered to provide propping to the top edge of the walls.

The perimeter walls were considered as piers with an average width of 1.5 m. The internal wythe of the wall was found to have a rating of 30% and the external veneer was assessed to be 20%. Propping of the top edge is considered to occur from the timber roof trusses.

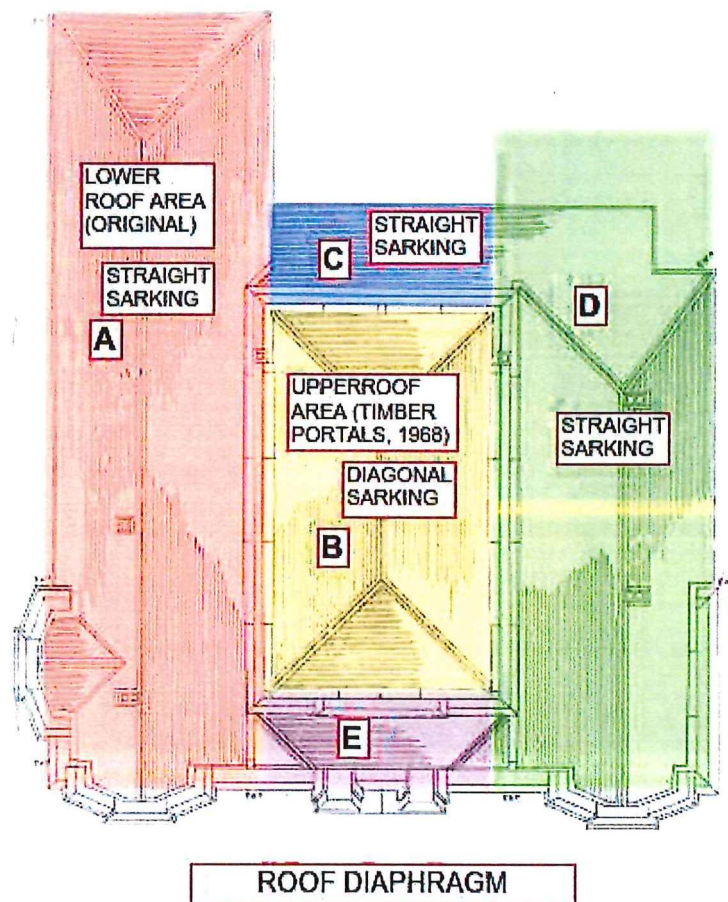
Figure 23. Roof Diaphragms

Our assessment found diaphragm B, which was constructed at a later date of 1968, has a rating of 85% NBS (IL2) and the lower roof diaphragm has been assessed to be 50% NBS (IL2). These ratings are limited by the deflection incompatibility with the face-loaded URM walls due to the low stiffness obtained from timber sarking.

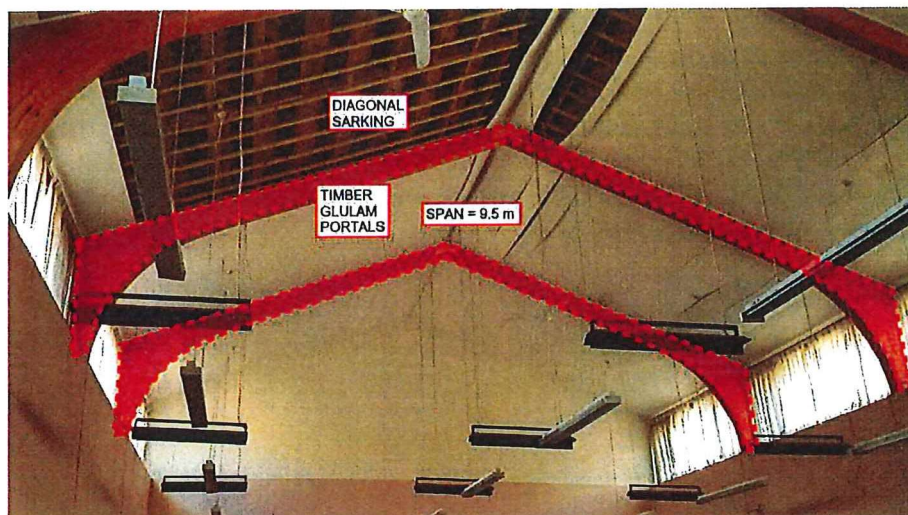
The glulam portals used to create the roof of the courtroom area were built in 1968 as part of the alterations work on building following the damage from the Inangahua earthquake and are shown in Figure 24. Due to the roof diaphragm being very flexible, it is expected that the portals will be required to work out-of-plane to resist the lateral demands. The portals were assessed using parts and portions loading and rated as 55% NBS (IL2).

Figure 24. Central Courtroom Timber GLVL Portals

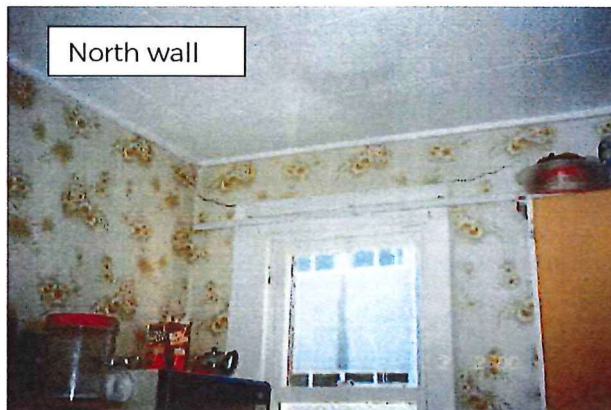
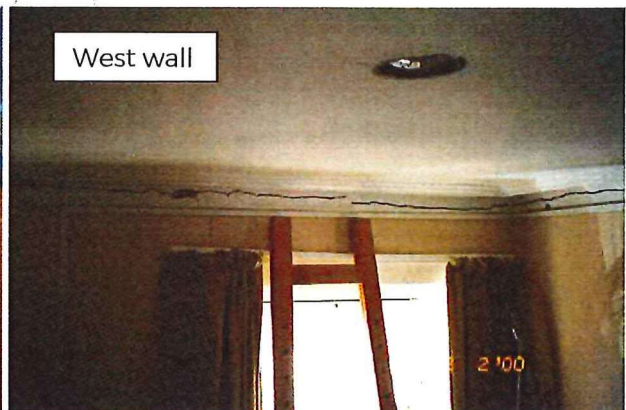
**February** – Photos taken

It was noticed that the cracks in the tea-room, law library, court room, toilet, and staff-room had travelled down from the ceiling and to the corners of the window frames and appeared to be widening.

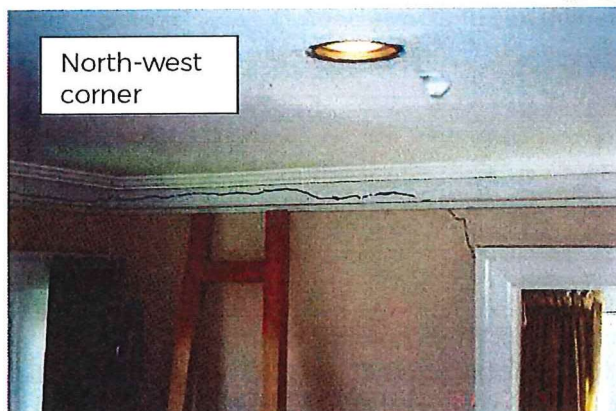
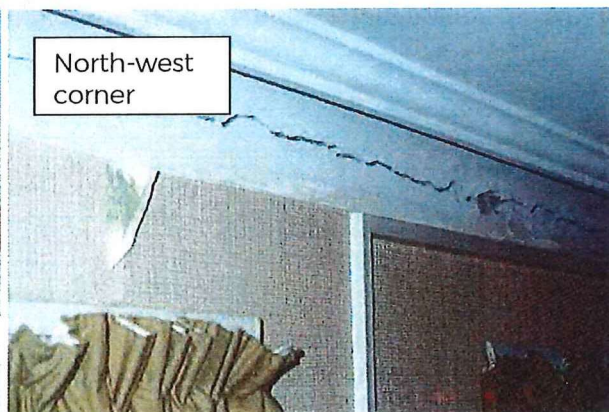
**August** – Photos taken

**September** – In response to the concerns raised by the Department for Courts, Opus confirmed that the cracks had grown in size since the previous inspection in March 2000. Highlighting that if the building was to remain that it should be strengthened before mid-2003.

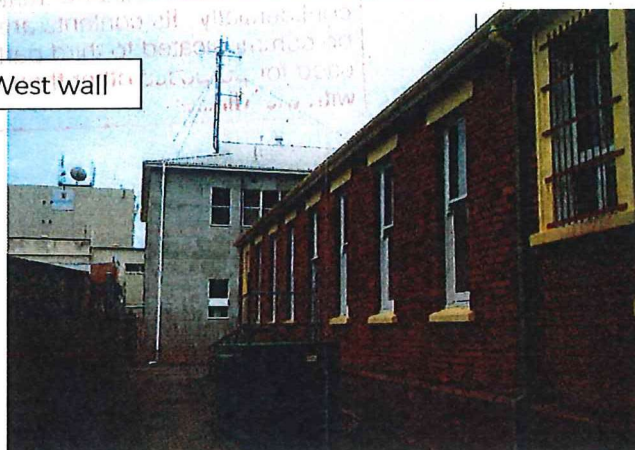
West wall

**March** – A visual assessment was conducted to inspect the condition of the exterior brick veneer along the western wall of the courthouse. It was concluded that the wall had continued to deteriorate further, with visible cracking and bowing of the piers. Further investigation was recommended.
