Grey District Lifelines Plan

Communities and Council

Alpine Fault Earthquake Scenario & Lifelines Vulnerability Assessment

Grey District Council

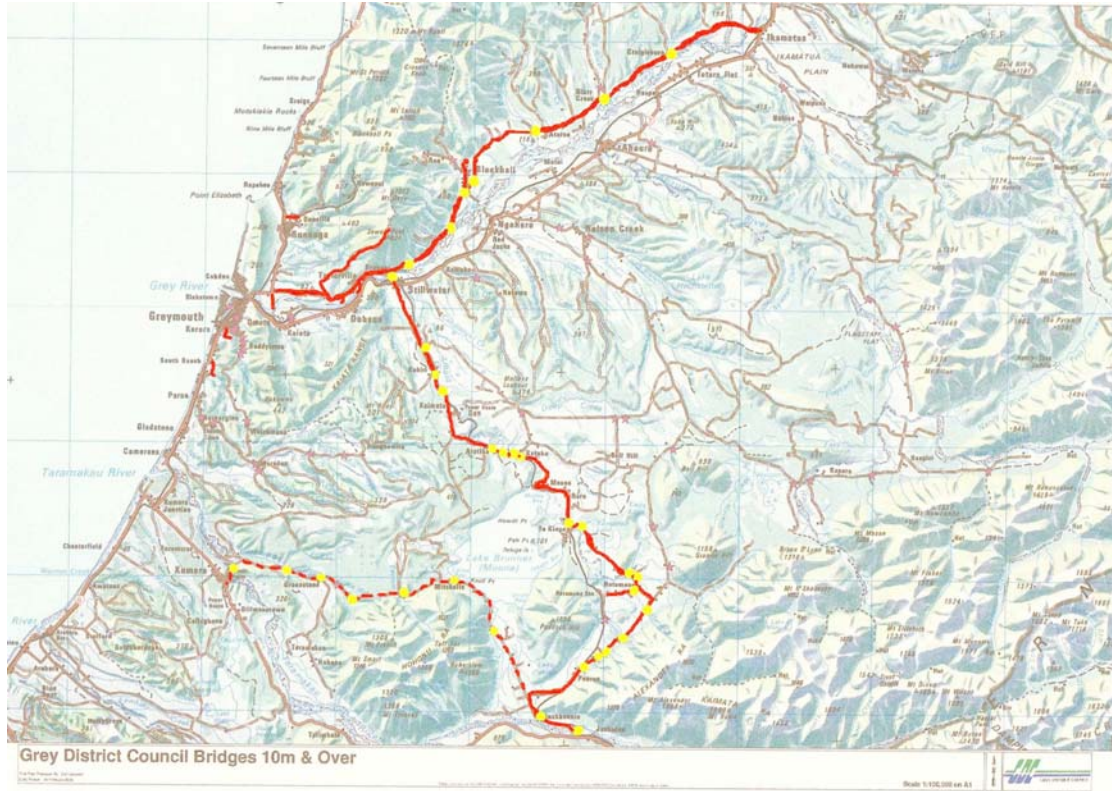
Figure 4.4: Critical GDC Roads

Critical GDC roads (red) with major bridges (yellow dots) providing alternative routes to State Highways and providing access to critical facilities such as potable water pump stations and reservoirs.

The critical roads in Figure 4.4 represent alternative routes to the State Highway 73 between Jacksons, Kumara and Greymouth. In the past, the GDC road between Jacksons and Stillwater has been used when the Jacksons to Kumara Junction road has been close due to slips or accidents.

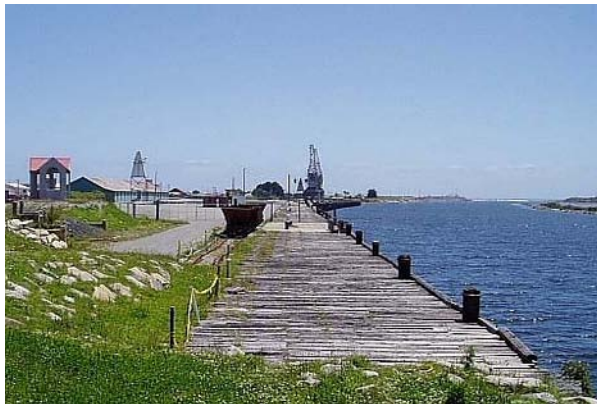
Figure 4.6: Port of Greymouth

Photo of the Port of Greymouth looking towards the mouth of the Grey River.

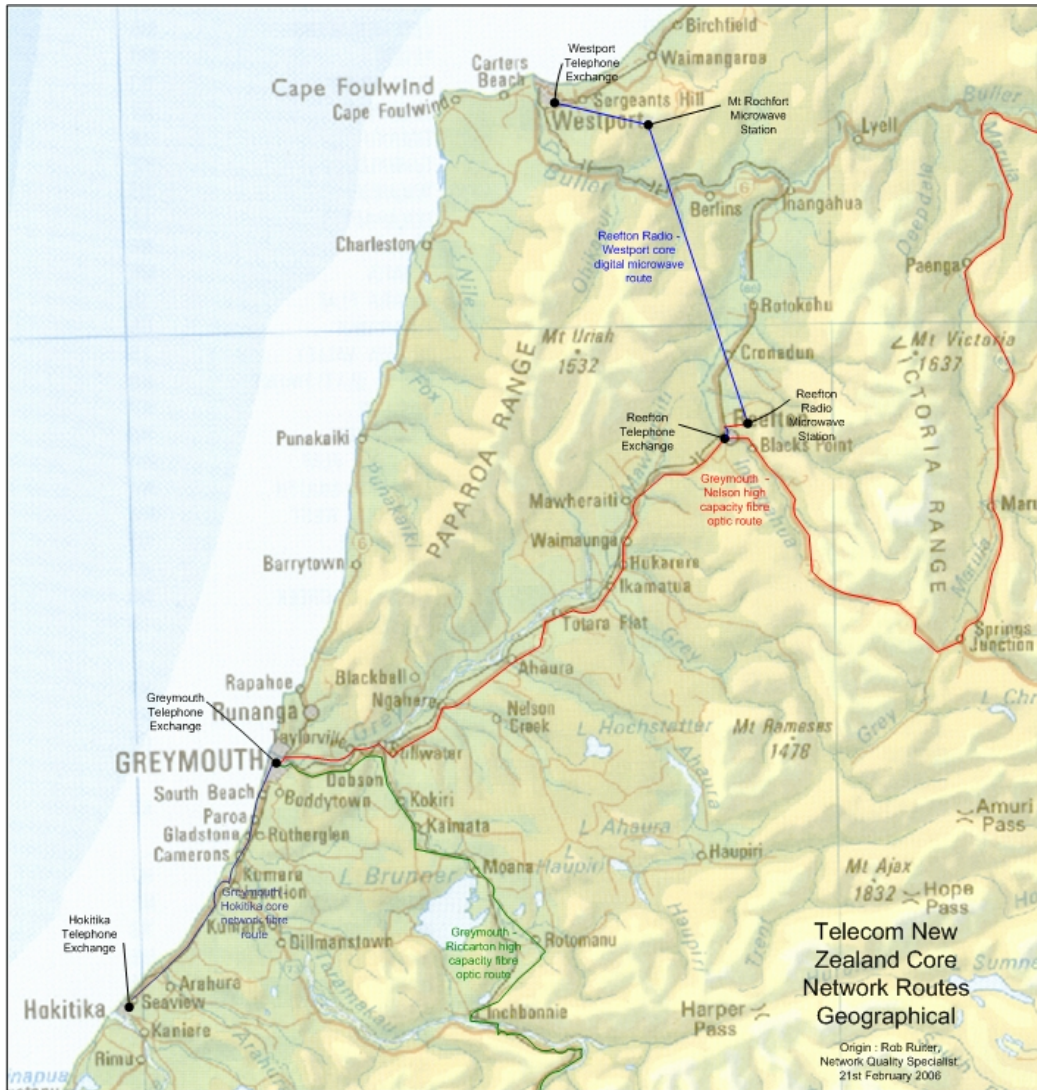
Figure 4.31: Telecom Networks – West Coast

Telecom operates the largest landline system on the West Coast together with a cellular network and support services for other telecommunication companies. The integrity of the Telecom network, both landlines and mobile, is managed from a centre in Hamilton. The West Coast area is connected to the national network by three principal core or transport network paths. These are shown in Figure 4.31 and are described as follows:

- Between Westport and Reefton: Digital Microwave Radio to Mt Rochfort, forwarded on to Reefton Radio and thence over fibre to the Reefton exchange and on via fibre to either Greymouth or Nelson exchanges.
