In the matter of Resource consent applications by TiGa Minerals and Metals
Ltd to establish and operate a mineral sands mine on State
Highway 6, Barrytown (RC-2023-0046; LUN3154/23)

Statement of evidence of Cameron Andrew Wylie

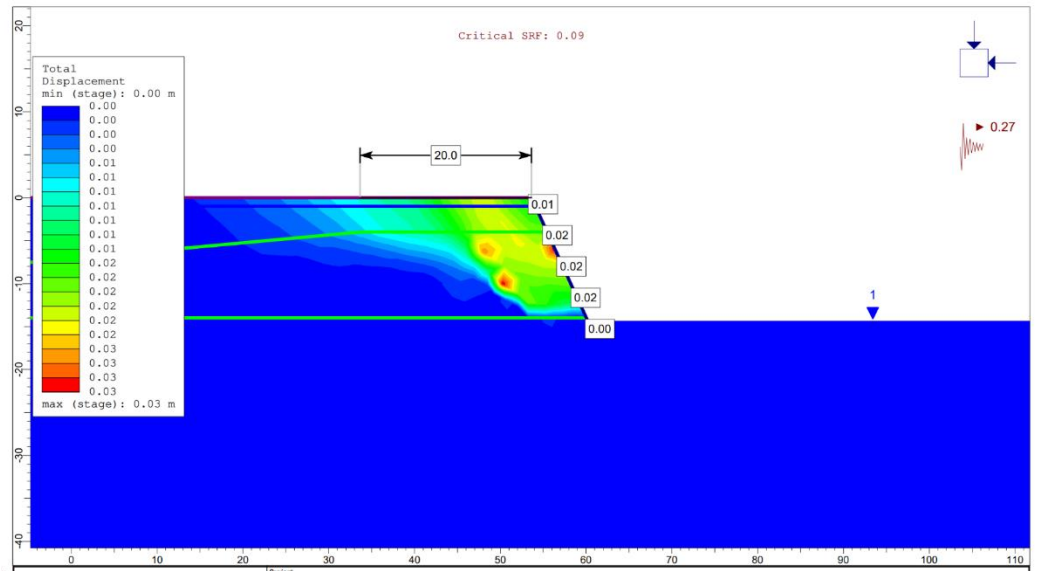
Figure 3 Indicative Displacement due to ULS event

- (b) Seismic case ULS (0.27g) FoS = 0.7 with indicative displacement < 0.05m at the excavation face and 0.01m at a distance ~20m behind the crest of the cut face as shown in Figure 3.

- (c) Check seismic case for pga=0.53 also indicates the magnitude of displacement < 0.04m all within the 20m setback.

33 Displacement of this magnitude is expected to be practically not visible to the eye, with:

- (a) Very Low likelihood to breach the waterbodies outside of the 20m setback.
